Subject: EPA Comments on “Draft Coal Combustion Residue Impoundment: Round 12 – Dam Assessment Report – City of Ames Power Plant”

January 3, 2014

This assessment of the stability and functionality of the City of Ames Power Plant Ash Pond and Lime Cell impoundment dikes is based on a review of available documents and on the site assessment conducted by Dewberry personnel on August 20, 2012. This is an unusual management unit configuration, because the Ash Pond operated by the City of Ames Power Plant shares an impoundment with the Water Department's Lime Cell. We found the supporting technical documentation incomplete (Section 1.1.3). As detailed in Section 1.2, there are two recommendations that would help to ensure a safe and trouble-free operation.

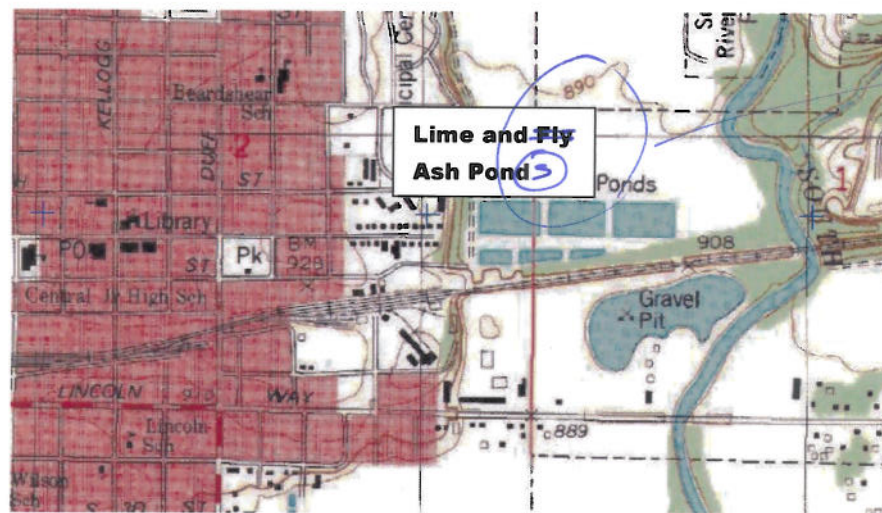
Figure 2.6-1: Lime and Ash Pond Area Topography

The Ames Power Plant is located on the east side of Ames, Iowa. The area to the west of the Lime and Ash Pond is heavily developed with residential, commercial, industrial, and transportation facilities. Topography in the area slopes to the east toward the South Skunk River, about 900 feet west of the Lime and Ash Pond.⁵ Based on the size of the impoundment, and site topographic conditions, a release due to failure or misoperation of the impoundment embankments is not expected to impact critical infrastructure facilities. Area topographic conditions are shown on Figure 2.6-1.
